ASBESTOS REPORT REGISTER & MANAGEMENT PLAN

Date of Inspection: 29/05/2017

For the Property at: Seonee Park Scout Group

Rockhampton-Yeppoon Road ROCKHAMPTON Q 4701

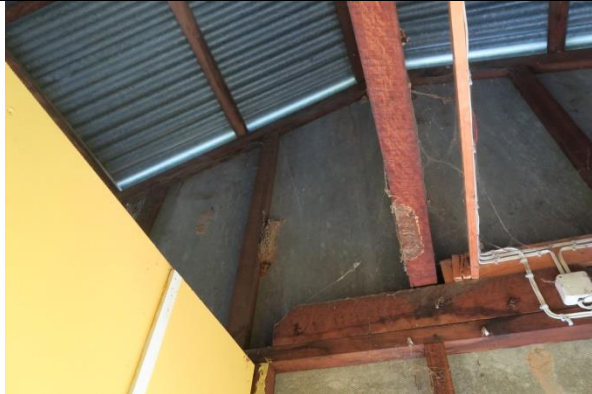
<p>Location: Bunk House Internal</p> <p>Concern: Gable Ends and Infill panels above Doorways are unpainted.</p> <p>Recommendation: Paint Panels and Gables.</p>

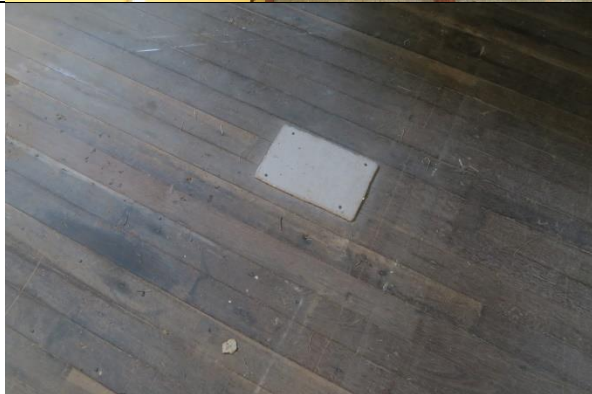
<p>Location: Bunk House Internal</p> <p>Concern: Patch on Floor is unpainted.</p> <p>Recommendation: Paint panel. Or Remove.</p>

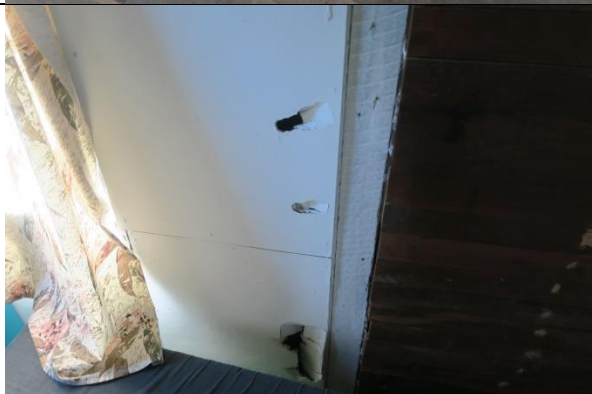
<p>Location: Bunk House Internal (Rear Right Cubicle)</p> <p>Concern: Sheeted walls are unpainted and one panel has damage.</p> <p>Recommendation: Paint raw edges, patch holes and paint.</p>

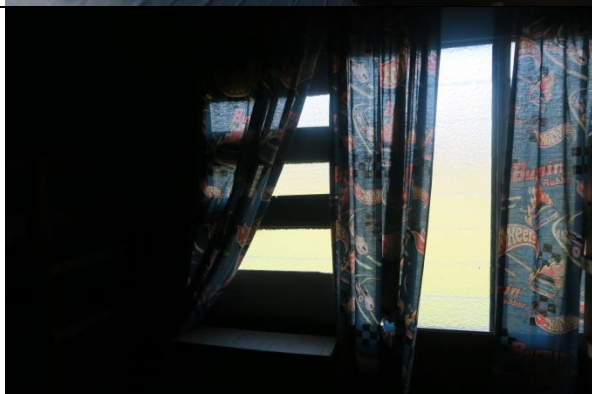
<p>Location: Bunk House Internal</p> <p>Concern: Louvers are unpainted.</p> <p>Recommendation: Paint Louvers.</p>

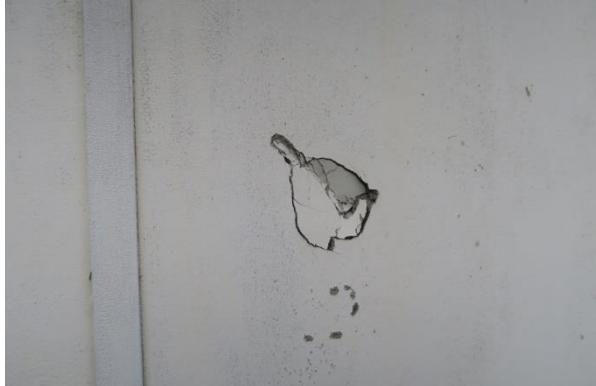
<p>Location: Amenities Block External</p> <p>Concern: Walls are damaged with holes that have exposed material.</p> <p>Recommendation: Paint raw edges, patch holes and paint.</p>

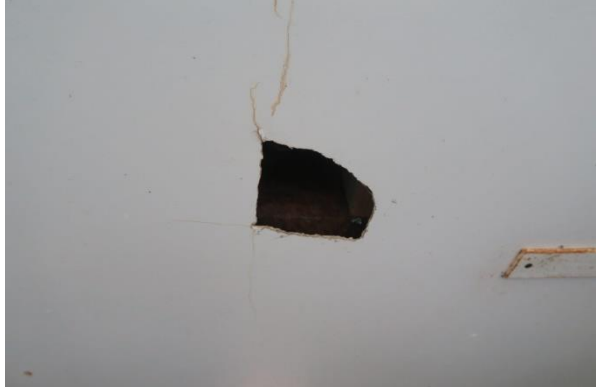
<p>Location: Amenities Block Hallway</p> <p>Concern: Damage to ceiling panel with exposed edges.</p> <p>Recommendation: Paint raw edges, patch holes and paint.</p>

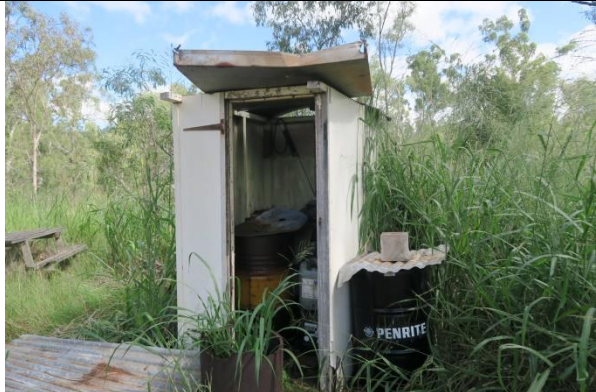
<p>Location: Old Toilet</p> <p>Concern: Walls are in poor condition and unpainted.</p> <p>Recommendation: Paint walls or remove building.</p>

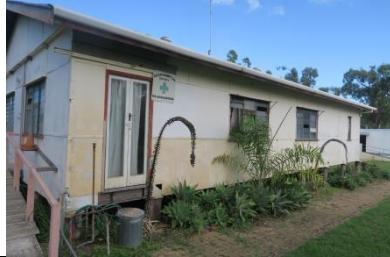
Floor Level	Location	Area	Type of Material	Type	Condition	Remedial Works	Risk Level	Sampling	Sample No.	Content	Photographic Evidence
GL	Bunk House – External of building	Walls	Fibre Cement Sheeting Flat	NF	P	Yes	M	A	-	AA

29/05/2017 Re-Inspection		This item has had works carried out and is now in Good Condition. The Risk Rating has been lowered accordingly.			G	No	L	A	-	AA

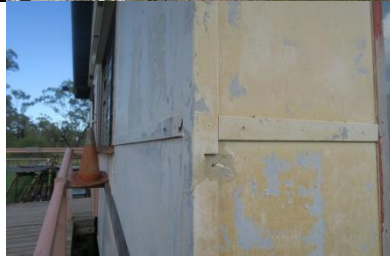
GL	Bunk House – External of building	Walls	Cover Strips - Fibre Cement Stripping	NF	P	Yes	M	A	-	AA

Floor Level	Location	Area	Type of Material	Type	Condition	Remedial Works	Risk Level	Sampling	Sample No.	Content	Photographic Evidence
29/05/2017 Re-Inspection		This item has had works carried out and is now in Good Condition. The Risk Rating has been lowered accordingly.			G	No	L	A	-	AA

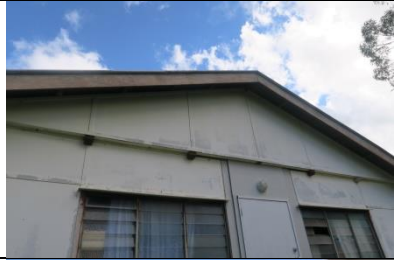
GL	Bunk House – External of building	Gable Ends	Fibre Cement Sheeting Flat	NF	G	No	L	A	-	AA

29/05/2017 Re-Inspection		There has been no change in the condition of this item.			G	No	L	A	-	AA

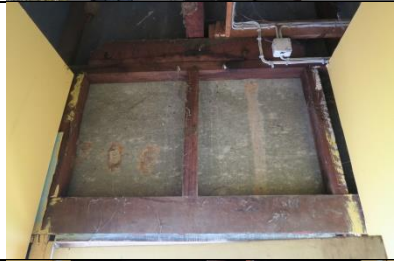
GL	Bunk House – Internal	Infill Panels above Doorways	Fibre Cement Sheeting Flat	NF	N	Yes	M	A	-	AA

29/05/2017 Re-Inspection		There has been no change in the condition of this item.			N	Yes	M	A	-	AA

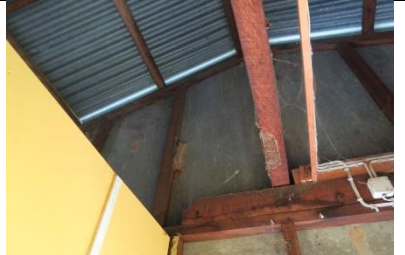
Floor Level	Location	Area	Type of Material	Type	Condition	Remedial Works	Risk Level	Sampling	Sample No.	Content	Photographic Evidence
GL	Bunk House – Internal	Gable Ends	Fibre Cement Sheeting Flat	NF	N	Yes	M	A	-	AA

29/05/2017 Re-Inspection		There has been no change in the condition of this item.			N	Yes	M	A	-	AA

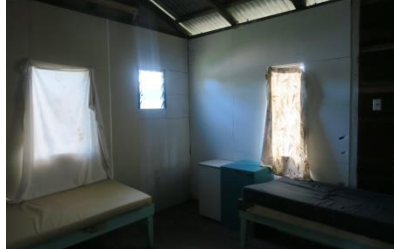
GL	Bunk House – Internal (Rear Right Cubicle)	Rear and Right Walls (Sheeted)	Fibre Cement Sheeting Flat	NF	N	Yes	M	A	-	AA

29/05/2017 Re-Inspection		There has been no change in the condition of this item.			N	Yes	M	A	-	AA

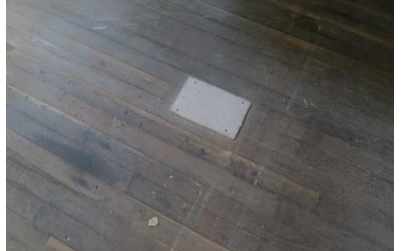
GL	Bunk House – Internal (Rear Right Cubicle)	Patch on Floor	Fibre Cement Sheeting Flat	NF	N	Yes	M	A	-	AA

Floor Level	Location	Area	Type of Material	Type	Condition	Remedial Works	Risk Level	Sampling	Sample No.	Content	Photographic Evidence
	29/05/2017 Re-Inspection	There has been no change in the condition of this item.			N	Yes	M	A	-	AA

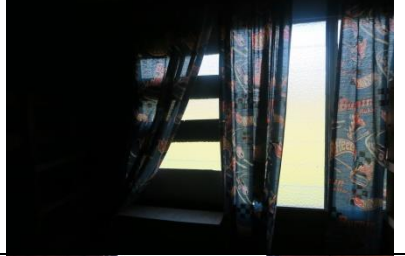
GL	Bunk House – Internal	Louvers	Fibre Cement Sheeting Flat	NF	N	Yes	M	A	-	AA

29/05/2017 Re-Inspection	There has been no change in the condition of this item.			N	Yes	M	A	-	AA

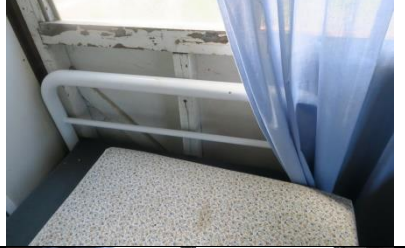
GL	Bunk House – Internal (Front Left Cubicle)	Infill Panel under Window	Fibre Cement Sheeting Flat	NF	G	No	L	A	-	AA

29/05/2017 Re-Inspection	There has been no change in the condition of this item.			G	No	L	A	-	AA

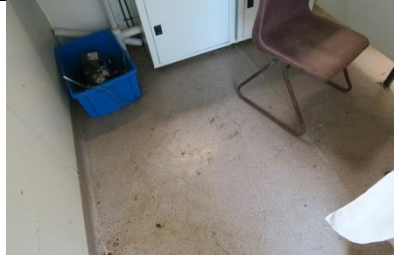
Floor Level	Location	Area	Type of Material	Type	Condition	Remedial Works	Risk Level	Sampling	Sample No.	Content	Photographic Evidence
GL	Female Toilet Demountable – Laundry	Floor	Vinyl Sheet Backing	F	G	No	L	A	-	AA

29/05/2017 Re-Inspection		There has been no change in the condition of this item.			G	No	L	A	-	AA

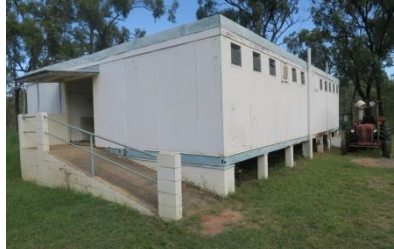
GL	Old Toilet Block – External	Walls	Fibre Cement Sheeting Flat	NF	N	Yes	M	A	-	AA

29/05/2017 Re-Inspection		There has been no change in the condition of this item.			N	Yes	M	A	-	AA

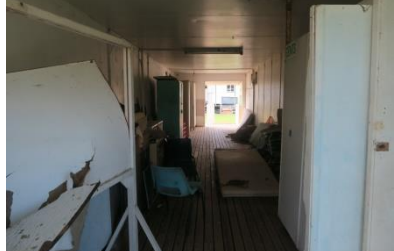
GL	Old Toilet Block – Hallway	Walls	Fibre Cement Sheeting Flat	NF	G	No	L	A	-	AA

Floor Level	Location	Area	Type of Material	Type	Condition	Remedial Works	Risk Level	Sampling	Sample No.	Content	Photographic Evidence
	29/05/2017 Re-Inspection	There has been no change in the condition of this item.			G	No	L	A	-	AA

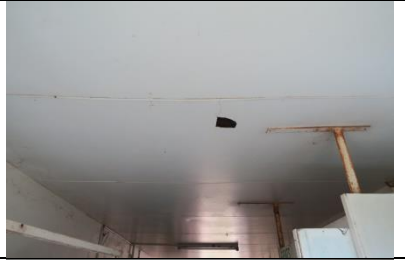
GL	Old Toilet Block – Hallway	Ceiling	Fibre Cement Sheeting Flat	NF	N	Yes	M	A	-	AA

29/05/2017 Re-Inspection	There has been no change in the condition of this item.			N	Yes	M	A	-	AA

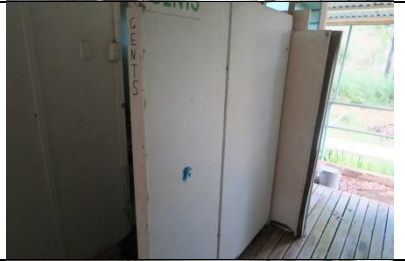
GL	Old Toilet Block – Hallway	Entry Dividers	Fibre Cement Sheeting Flat	NF	P	Yes	M	A	-	AA

29/05/2017 Re-Inspection	There has been no change in the condition of this item.			P	Yes	M	A	-	AA

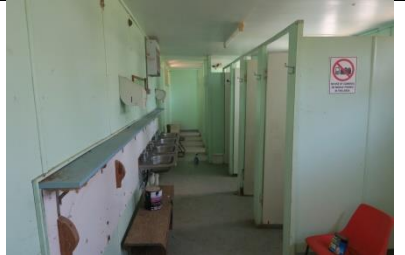
Floor Level	Location	Area	Type of Material	Type	Condition	Remedial Works	Risk Level	Sampling	Sample No.	Content	Photographic Evidence
GL	Old Toilet Block – Male Toilets	Walls	Fibre Cement Sheeting Flat	NF	G	No	L	A	-	AA

29/05/2017 Re-Inspection		There has been no change in the condition of this item.			G	No	L	A	-	AA

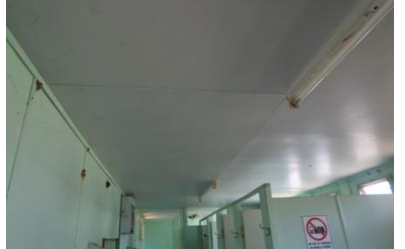
GL	Old Toilet Block – Male Toilets	Ceiling	Fibre Cement Sheeting Flat	NF	G	No	L	A	-	AA

29/05/2017 Re-Inspection		There has been no change in the condition of this item.			G	No	L	A	-	AA

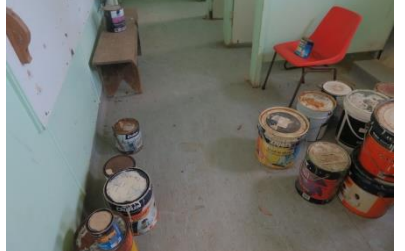
GL	Old Toilet Block – Male Toilets	Floor	Vinyl Sheet Backing	F	G	No	L	A	-	AA

Floor Level	Location	Area	Type of Material	Type	Condition	Remedial Works	Risk Level	Sampling	Sample No.	Content	Photographic Evidence
	29/05/2017 Re-Inspection	There has been no change in the condition of this item.			G	No	L	A	-	AA

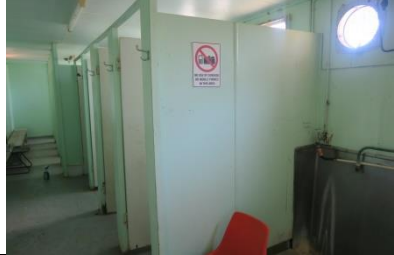
GL	Old Toilet Block – Male Toilets	Cubicle Dividers	Compressed Fibre Cement Sheeting	NF	G	No	L	A	-	AA

29/05/2017 Re-Inspection	There has been no change in the condition of this item.			G	No	L	A	-	AA

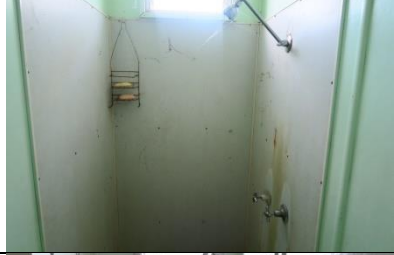
GL	Old Toilet Block – Male Toilets	Shower Paneling	Fibre Cement Sheeting Flat	NF	G	No	L	A	-	AA

29/05/2017 Re-Inspection	There has been no change in the condition of this item.			G	No	L	A	-	AA

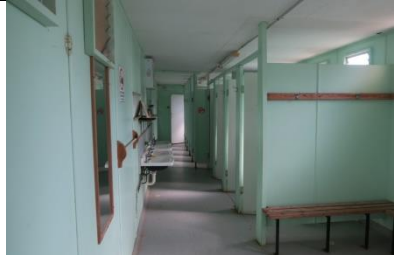
Floor Level	Location	Area	Type of Material	Type	Condition	Remedial Works	Risk Level	Sampling	Sample No.	Content	Photographic Evidence
GL	Old Toilet Block – Female Toilets	Walls	Fibre Cement Sheeting Flat	NF	G	No	L	A	-	AA

29/05/2017 Re-Inspection		There has been no change in the condition of this item.			G	No	L	A	-	AA

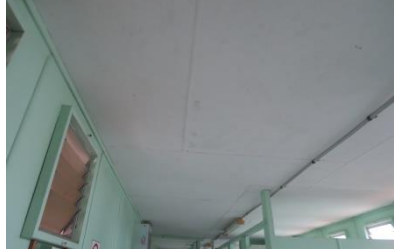
GL	Old Toilet Block – Female Toilets	Ceiling	Fibre Cement Sheeting Flat	NF	G	No	L	A	-	AA

29/05/2017 Re-Inspection		There has been no change in the condition of this item.			G	No	L	A	-	AA

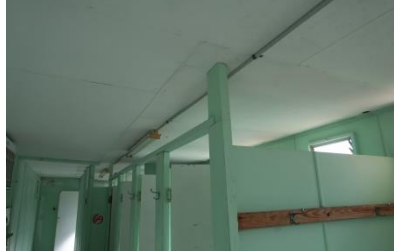
GL	Old Toilet Block – Female Toilets	Ceiling (Over Sowers)	Fibre Cement Sheeting Flat	NF	G	No	L	A	-	AA

Floor Level	Location	Area	Type of Material	Type	Condition	Remedial Works	Risk Level	Sampling	Sample No.	Content	Photographic Evidence
	29/05/2017 Re-Inspection	There has been no change in the condition of this item.			G	No	L	A	-	AA

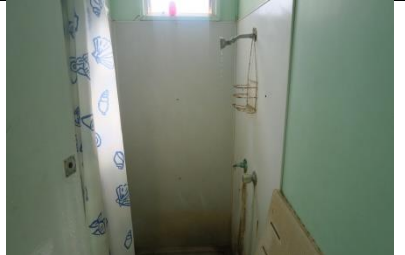
Floor Level	Location	Area	Type of Material	Type	Condition	Remedial Works	Risk Level	Sampling	Sample No.	Content	Photographic Evidence
GL	Old Toilet Block – Female Toilets	Shower Paneling	Fibre Cement Sheeting Flat	NF	G	No	L	A	-	AA

29/05/2017 Re-Inspection		There has been no change in the condition of this item.			G	No	L	A	-	AA

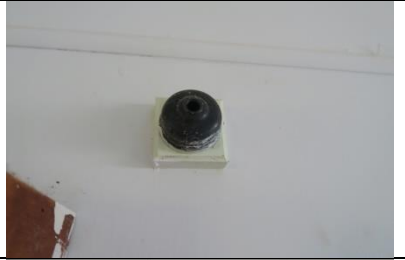
GL	Den – Hall	Wall	Bakelite Switch	NF	G	No	L	A	-	AA

29/05/2017 Re-Inspection	There has been no change in the condition of this item.			G	No	L	A	-	AA

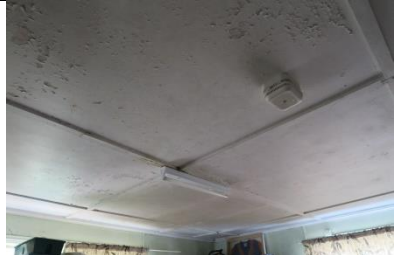
Floor Level	Location	Area	Type of Material	Type	Condition	Remedial Works	Risk Level	Sampling	Sample No.	Content	Photographic Evidence
GL	Den – Leader’s Room	Ceiling	Fibre Cement Sheeting Flat	NF	G	No	L	A	-	AA

29/05/2017 Re-Inspection		There has been no change in the condition of this item.			G	No	L	A	-	AA

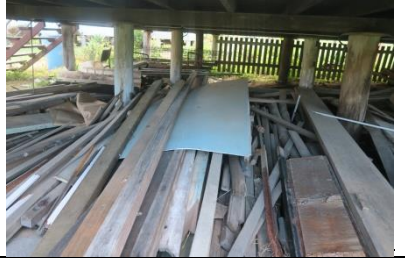
Floor Level	Location	Area	Type of Material	Type	Condition	Remedial Works	Risk Level	Sampling	Sample No.	Content	Photographic Evidence
GL	Bunk House— Under Building	Spare Panels store under building	Fibre-Cement Sheeting Flat	NF	N	Yes	M	A	-	AA

29/05/2017 Re-Inspection		This item has been removed
